**Flood Control Project Maintenance  
Levee Inspections**

**Fall 2014 Levee Maintenance Deficiency Summary Report**

**Sacramento River Basin**

**Reclamation District No. 0150 Merrit Island**

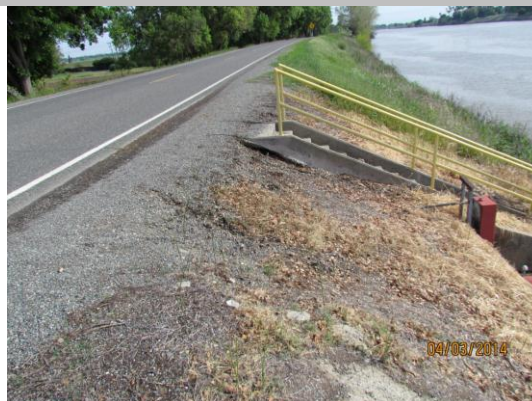
Photo 1 of 2 : FA\_2014\_RD0150\_16\_6\_20141021\_00002.jpg

LM Start	0.40	Rating **	M	Issue No.	6
LM End	0.40	Issue Type +	Ma	Location *	WS
Category	Earthen Levee			GPS Latitude/Longitude	
				Start	End
Item	Slope Stability			38.332717 °	38.332717 °
				-121.572083 °	-121.572083 °
DWR ID	DWR_RD0150_02_s_2012_6				
Action/Comments					
Repair the levee slope damaged by foot traffic and prevent access where possible.

Updated photo of the slope instability on the waterside of the levee looking upstream during spring 2014 inspection.

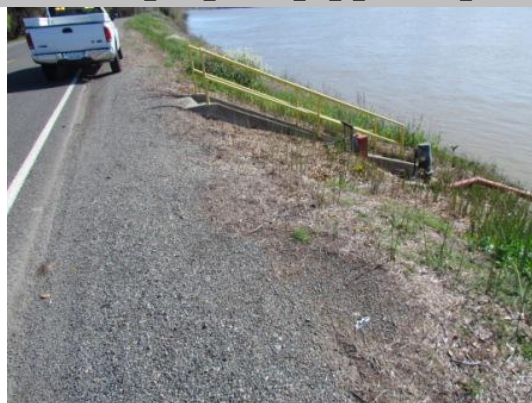
Photo 2 of 2 : FA\_2014\_RD0150\_16\_6\_20141021\_00003.jpg

Slope instability was found on the waterside of the levee looking upstream.

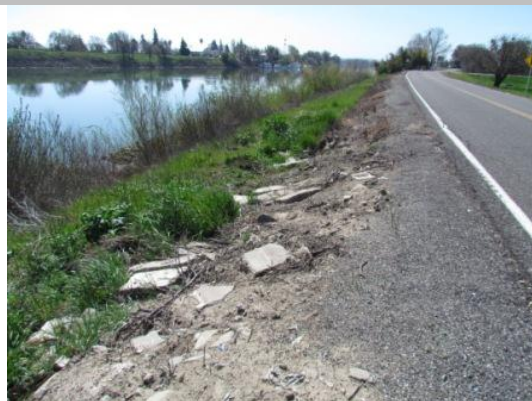
Photo 1 of 1 : FA\_2014\_RD0150\_16\_10\_20141021\_00006.jpg

Debris was found on the waterside slope of the levee looking downstream during Spring 2013 inspection.

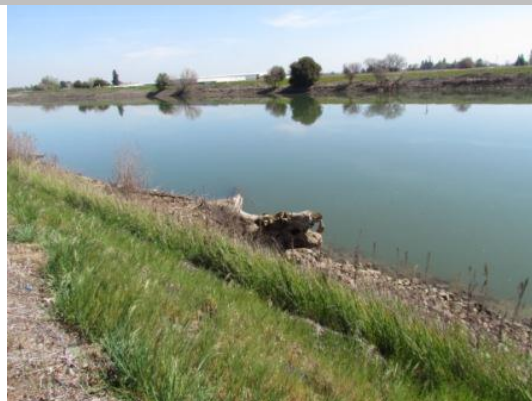
Photo 2 of 2 : FA\_2014\_RD0150\_16\_18\_20141021\_00013.jpg

A tree trunk was found on the waterside toe of the levee looking upstream during spring 2013 inspection.

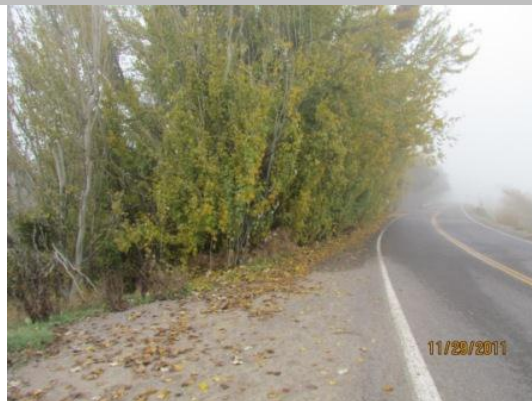
Photo 2 of 2 : FA\_2014\_RD0150\_16\_91\_20141021\_00043.jpg

Landscaping was found landside of the levee looking upstream.

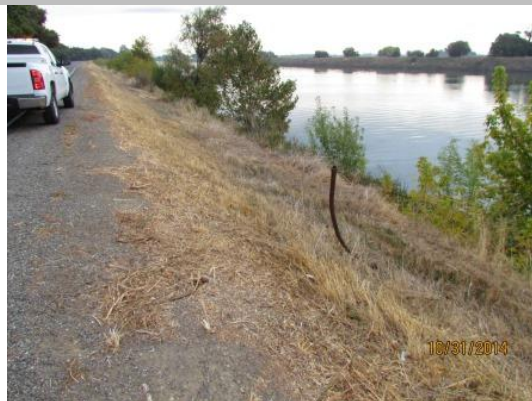
Photo 1 of 1 : FA\_2014\_RD0150\_16\_48\_20141104\_00072.jpg

LM Start	1.75	Rating **	M	Issue No.	48
LM End	1.75	Issue Type +	En	Location *	WS
Category	Earthen Levee			GPS Latitude/Longitude	
				Start	End
Item	Encroachments			38.345583 °	38.345583 °
				-121.554507 °	-121.554507 °
DWR ID	DWR_RD0150_02_f_2014_48				
Action/Comments					
Pole					
Inspector Comments: A pole was found on the waterside slope of the levee. Most probably is connected to a pump.

A pole/pipe was found on the waterside slope of the levee looking upstream.

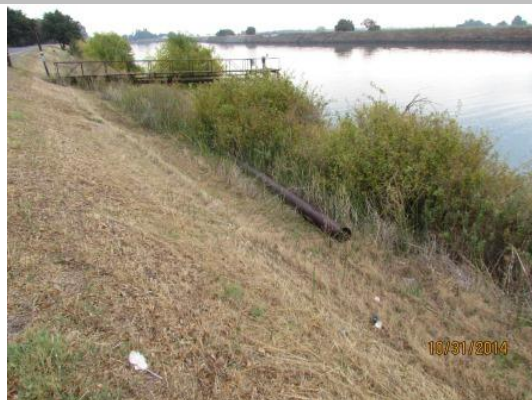
Photo 1 of 1 : FA\_2014\_RD0150\_16\_50\_20141104\_00073.jpg

LM Start	1.92	Rating **	M	Issue No.	50
LM End	1.92	Issue Type +	Ma	Location *	WS
Category	Earthen Levee			GPS Latitude/Longitude	
				Start	End
Item	Encroachments			38.346323 °	38.346323 °
				-121.551568 °	-121.551568 °
DWR ID	DWR_RD0150_02_f_2014_50				
Action/Comments					
Pipe Inspector Comments: An abandoned pipe was found on the waterside of the levee.

A pipe was found on the waterside toe of the levee looking upstream.

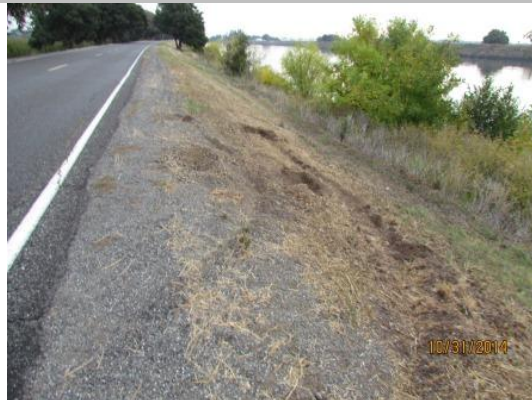
Photo 1 of 1 : FA\_2014\_RD0150\_16\_52\_20141104\_00074.jpg

LM Start	1.96	Rating **	M	Issue No.	52
LM End	1.96	Issue Type +	Ma	Location *	WS
Category	Earthen Levee			GPS Latitude/Longitude	
				Start	End
Item	Slope Stability			38.346462 °	38.346462 °
				-121.550978 °	-121.550978 °
DWR ID	DWR_RD0150_02_f_2014_52				
Action/Comments					
Repair the levee slope damaged by vehicle traffic and prevent access where possible.					
Inspector Comments: Rutting caused by vehicles.

A slope instability was found on the waterside slope of the levee looking upstream.

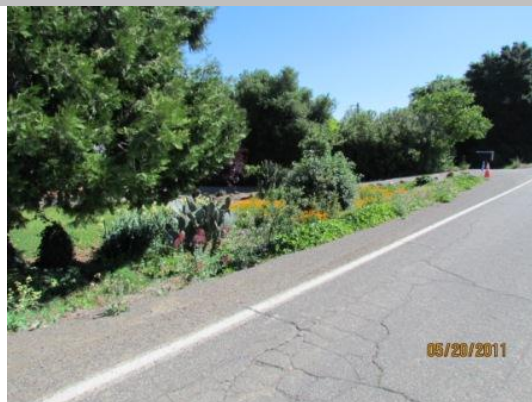
Photo 1 of 1 : FA\_2014\_RD0150\_16\_88\_20141021\_00041.jpg

Landscaping was found on the landside of the levee. The picture was taken from the crown looking upstream.

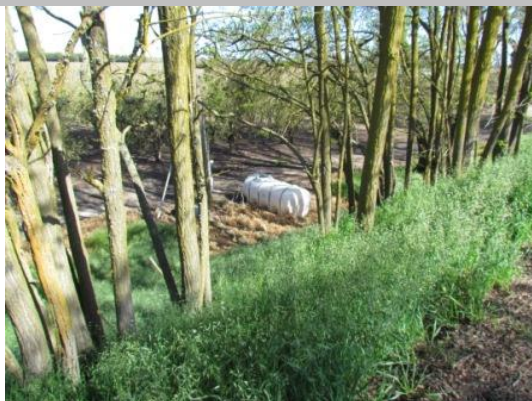
Photo 1 of 1 : FA\_2014\_RD0150\_16\_23\_20141021\_00015.jpg

A tank was found on the landside toe of the levee looking upstream.

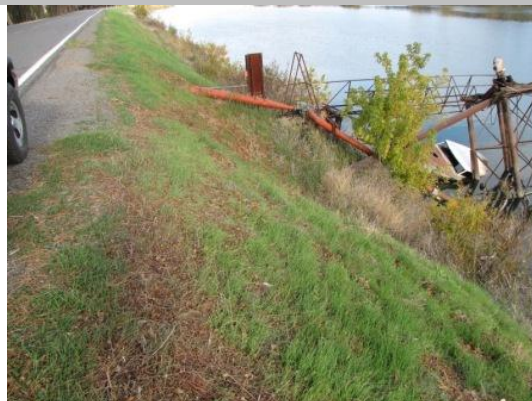
Photo 6 of 6 : FA\_2014\_RD0150\_16\_961\_20141021\_00046.jpg

Additional view of erosion on the waterward slope looking upstream. Note the damaged pump support, pump, and pipe just upstream of the site.

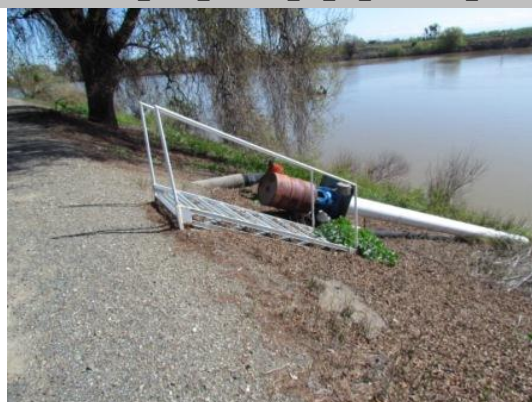
Photo 1 of 1 : FA\_2014\_RD0150\_16\_33\_20141021\_00021.jpg

A stairway was found on the waterside slope of the levee.

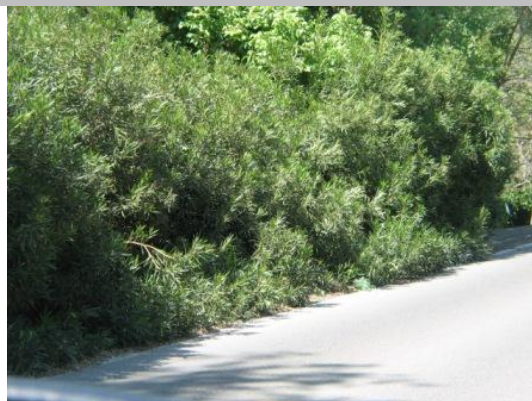
Photo 1 of 1 : FA\_2014\_RD0150\_16\_24\_20141021\_00016.jpg

Landscaping (Oleander) on landward slope from 4.33 to 4.35

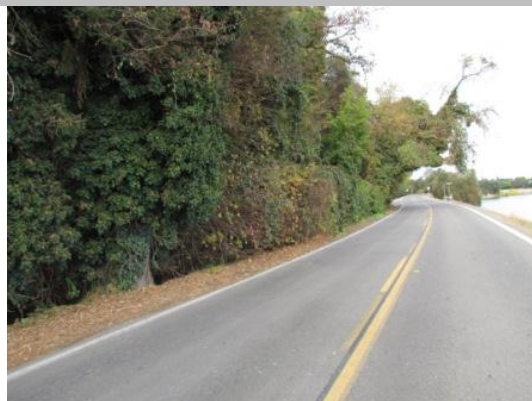
Photo 1 of 1 : FA\_2014\_RD0150\_16\_76\_20141021\_00036.jpg

Trees were obstructing the view of the landside slope of the levee looking upstream.

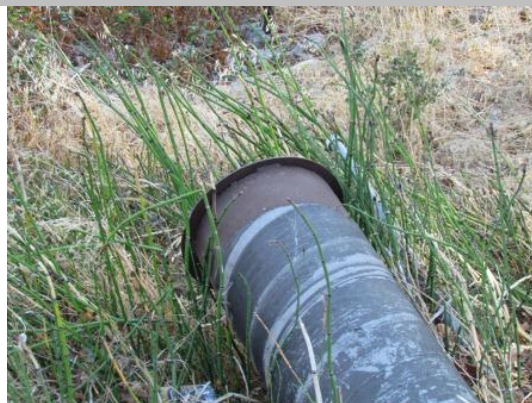
Photo 1 of 1 : FA\_2014\_RD0150\_16\_69\_20141021\_00034.jpg

The pipe cover doesn't appear to be water tight on the waterside slope of the levee. The picture was taken from the crown looking towards the toe of the levee during fall 2013 inspection.

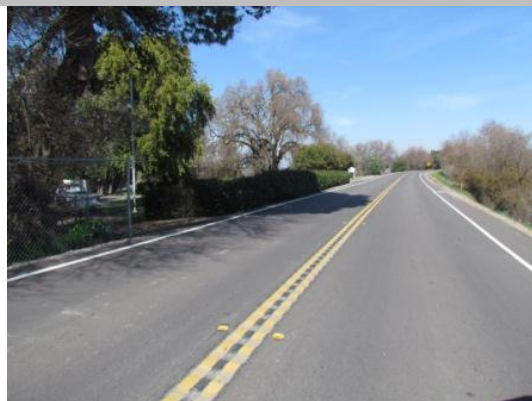
Photo 1 of 1 : FA\_2014\_RD0150\_16\_30\_20141021\_00019.jpg

Landscaping was found on the landside shoulder of the levee looking upstream.

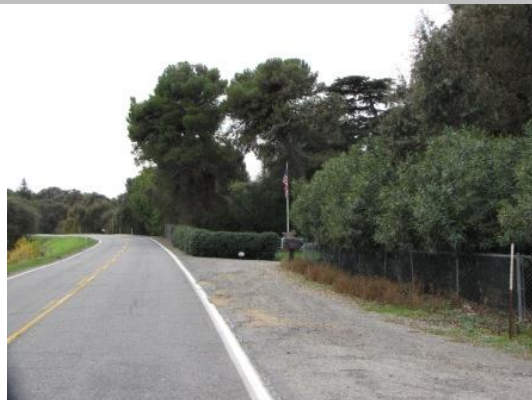
Photo 1 of 1 : FA\_2014\_RD0150\_16\_75\_20141021\_00035.jpg

View of landscaping along the landward shoulder and slope looking downstream.

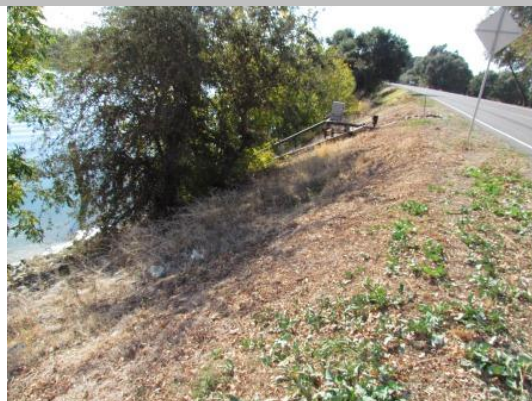
Photo 1 of 2 : FA\_2014\_RD0150\_16\_975\_20141021\_00051.jpg

View of minor slope instability on the waterside slope of the levee looking downstream during fall 2013 inspection.

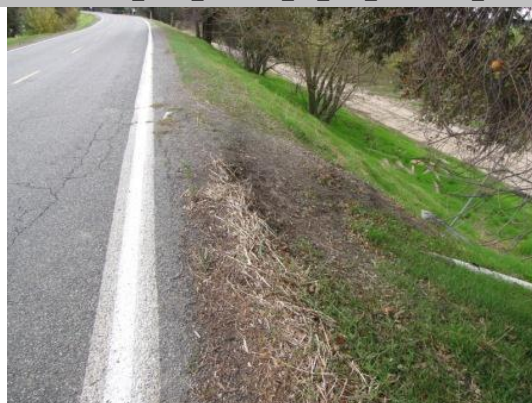
Photo 2 of 2 : FA\_2014\_RD0150\_16\_975\_20141021\_00052.jpg

View of a minor depression along the landward slope of the levee over a pipe penetration looking downstream.

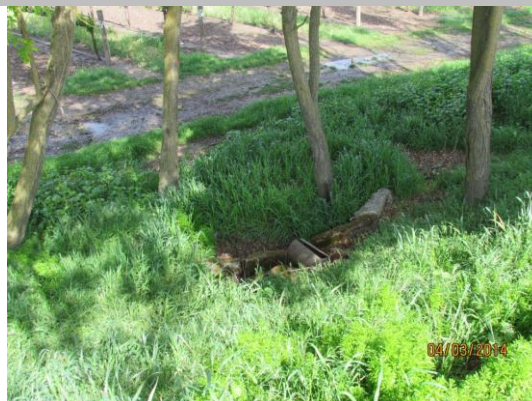
Photo 1 of 1 : FA\_2014\_RD0150\_16\_51\_20141021\_00028.jpg

View of a damaged pipe on the landside toe of the levee looking upstream.

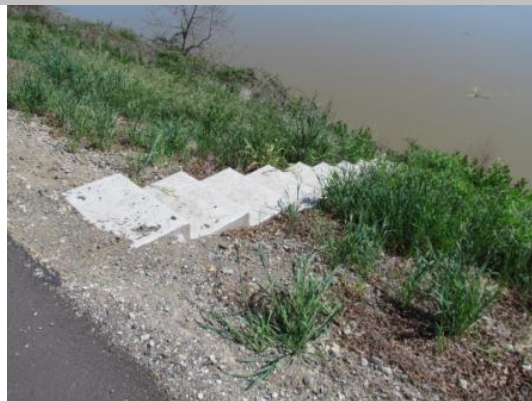
Photo 1 of 1 : FA\_2014\_RD0150\_16\_42\_20141021\_00025.jpg

A stairway was found on the waterside slope of the levee looking upstream.

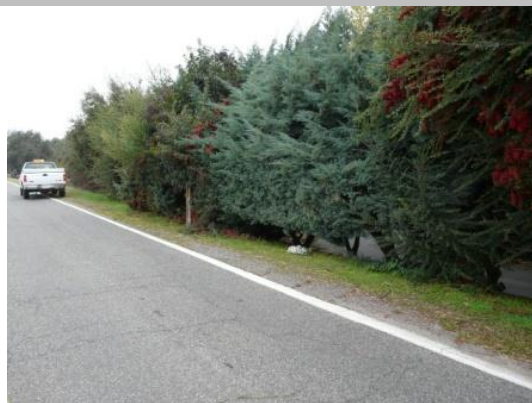
Photo 1 of 1 : FA\_2014\_RD0150\_16\_64\_20141021\_00032.jpg

Landscaping providing a screen for a residence on landside of levee  
from LM 6.68 to LM 6.72

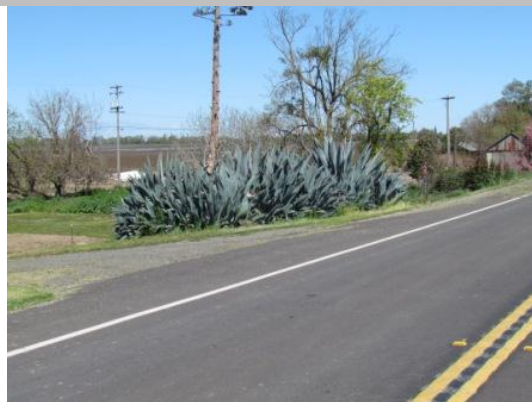
Photo 1 of 1 : FA\_2014\_RD0150\_16\_43\_20141021\_00026.jpg

Century plants were found on the landside of the levee looking upstream.

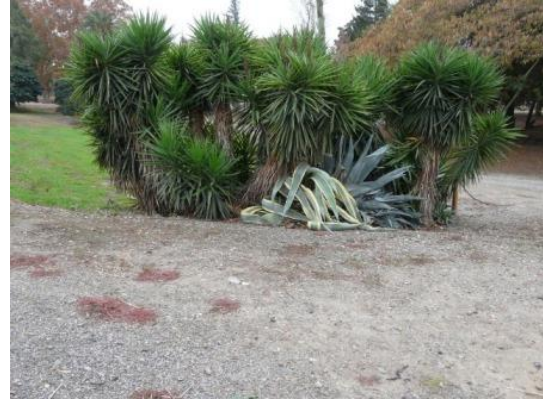
Photo 1 of 1 : FA\_2014\_RD0150\_16\_56\_20141021\_00029.jpg

Landscaping on landside of levee at LM 7.92

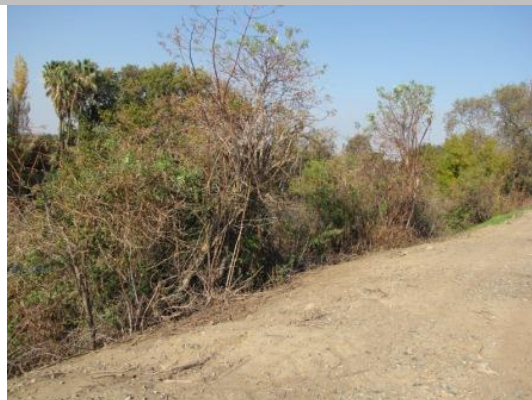
Photo 1 of 1 : FA\_2014\_RD0150\_17\_936\_20141021\_00104.jpg

View of elderberry bush within 20 feet of shoulder blocking visibility and access.

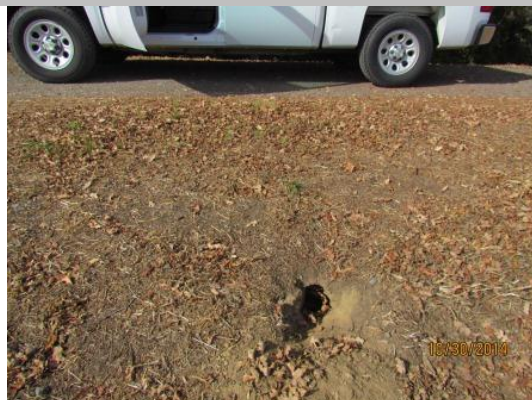
Photo 1 of 1 : FA\_2014\_RD0150\_17\_74\_20141104\_00119.jpg

A rodent hole was found on the landside of the levee looking upstream.

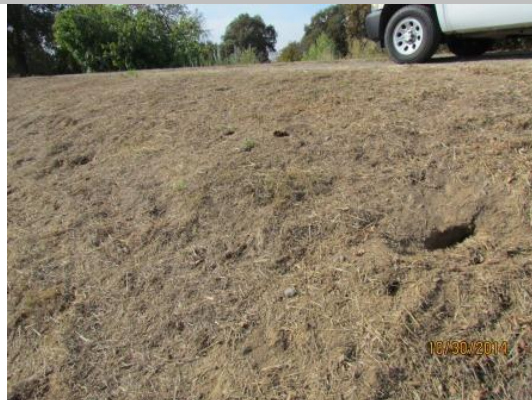
Photo 1 of 1 : FA\_2014\_RD0150\_17\_54\_20141104\_00120.jpg

View of an animal hole on the landside of the levee looking downstream.

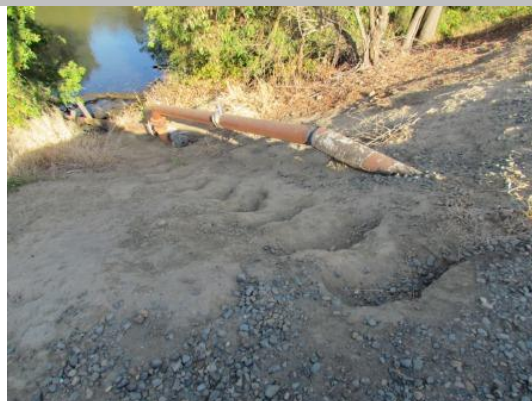
Photo 1 of 2 : FA\_2014\_RD0150\_17\_50\_20141021\_00041.jpg

Steps were dug next to the pipe and also erosion was found near the vicinity of the pipe on the waterside slope of the levee looking upstream during fall 2013 inspection.

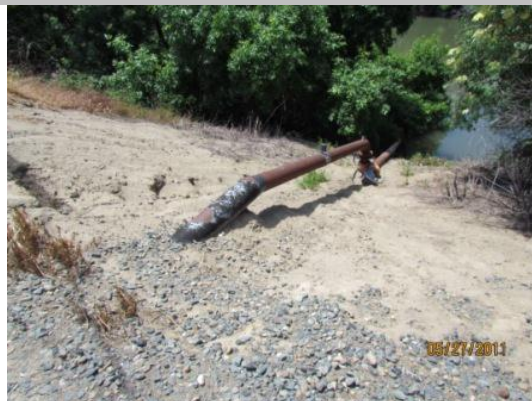
Photo 2 of 2 : FA\_2014\_RD0150\_17\_50\_20141021\_00042.jpg

Erosion was found on the waterside slope of the levee near the vicinity of the pipe. The picture was taken from the crown looking downstream.

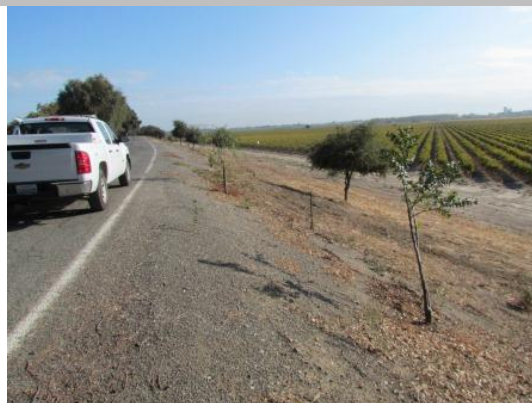
Photo 2 of 5 : FA\_2014\_RD0150\_17\_78\_20141021\_00079.jpg

Several newly planted tree were found on the landside slope of the levee looking upstream during the fall 2013 inspection.

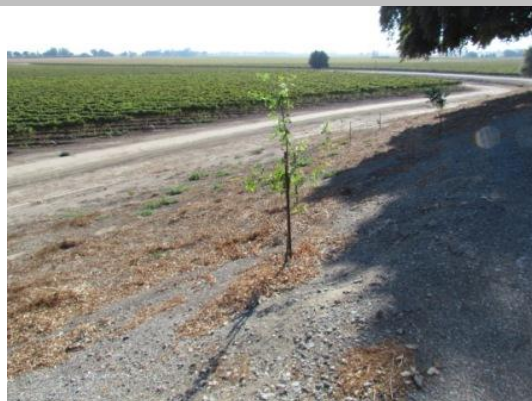
Photo 3 of 5 : FA\_2014\_RD0150\_17\_78\_20141021\_00080.jpg

New tree was found on the landside shoulder of the levee looking downstream. This picture was taken during fall 2012 inspection.

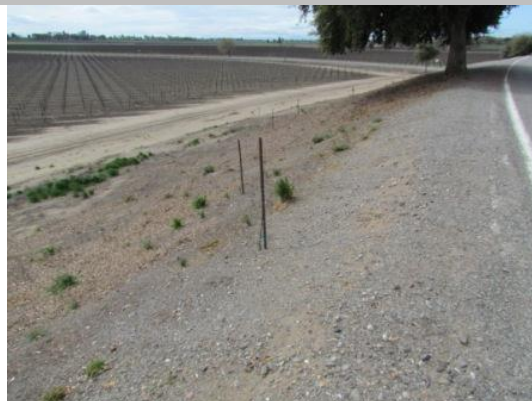
Photo 4 of 5 : FA\_2014\_RD0150\_17\_78\_20141021\_00081.jpg

New tree was planted on the landside of the levee looking downstream.

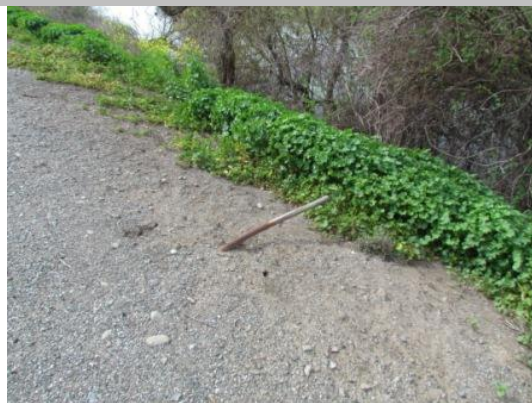
Photo 1 of 1 : FA\_2014\_RD0150\_17\_34\_20141021\_00026.jpg

A pipe was found on the waterside shoulder of the levee looking downstream during spring 2013 inspection.

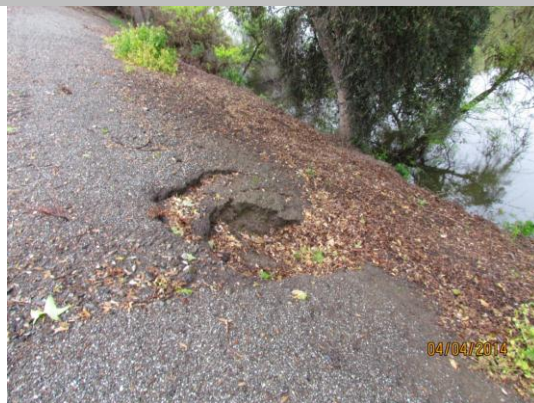
Photo 1 of 2 : FA\_2014\_RD0150\_17\_35\_20141021\_00027.jpg

Updated picture of the erosion on the waterside slope of the levee during spring 2014 inspection.

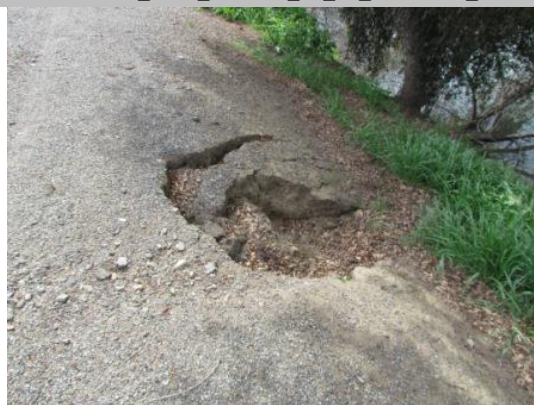
Photo 2 of 2 : FA\_2014\_RD0150\_17\_35\_20141021\_00028.jpg

Erosion was found on the waterside slope of the levee looking downstream during spring 2013 inspection.

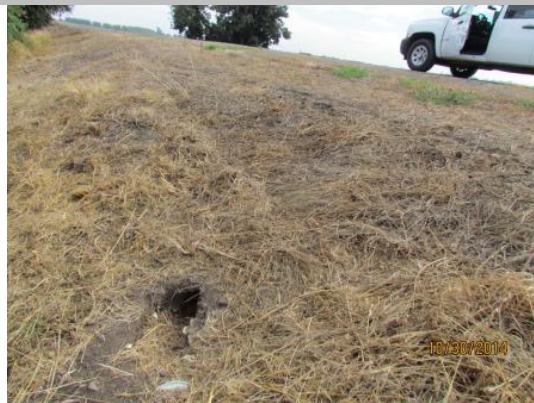
Photo 1 of 1 : FA\_2014\_RD0150\_17\_77\_20141104\_00122.jpg

A rodent hole was found on the waterside of the levee looking upstream.

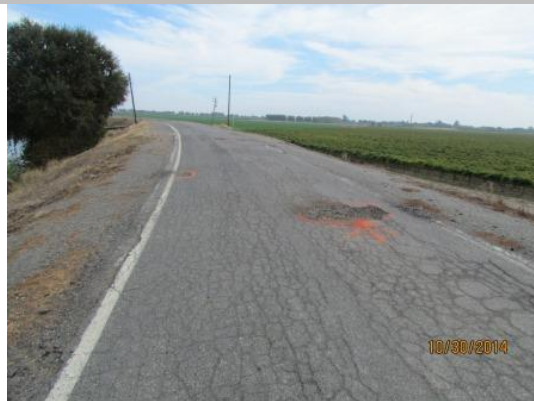
Photo 1 of 2 : FA\_2014\_RD0150\_17\_91\_20141104\_00123.jpg

Updated picture of the crown depression on the access road looking upstream during fall 2014 inspection.

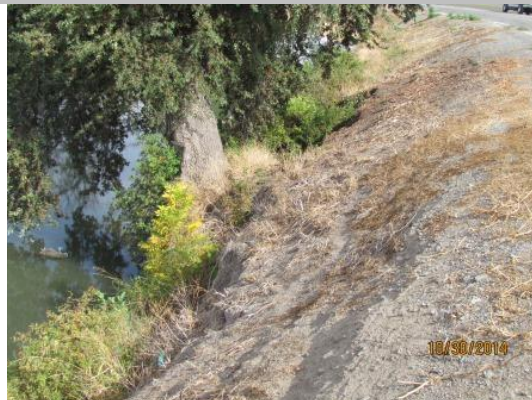
Photo 1 of 2 : FA\_2014\_RD0150\_17\_40\_20141104\_00124.jpg

Updated picture of the erosion on the waterside of the levee looking upstream during fall 2014 inspection.

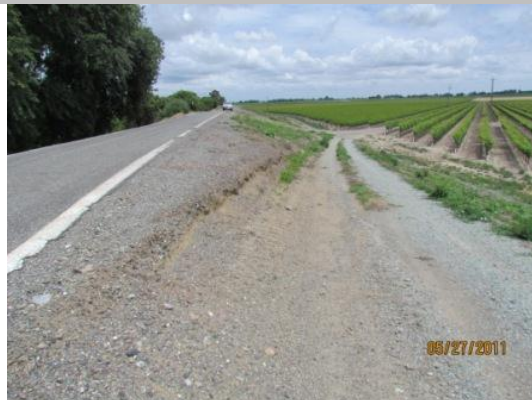
Photo 1 of 2 : FA\_2014\_RD0150\_17\_927\_20141021\_00097.jpg

Slope instability possible due to vehicular traffic on the landside of the levee. The picture was taken from the crown looking upstream during Spring 2011 inspection.

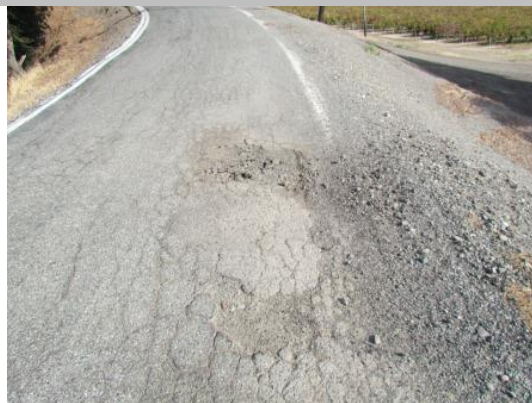
Photo 1 of 1 : FA\_2014\_RD0150\_17\_117\_20141021\_00095.jpg

Crown depression was found looking upstream during the fall 2013 inspection.

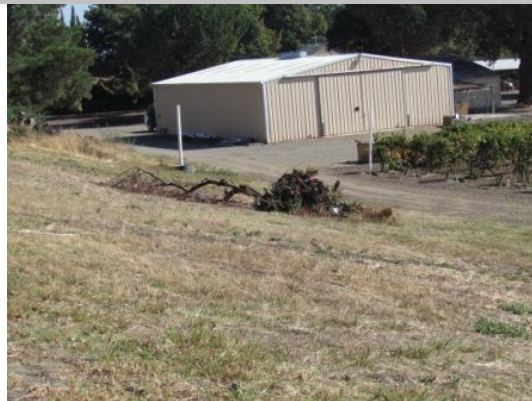
Photo 3 of 4 : FA\_2014\_RD0150\_17\_51\_20141021\_00045.jpg

Prunings were found on the landside of the levee looking upstream. This picture was taken during fall 2012 inspection.

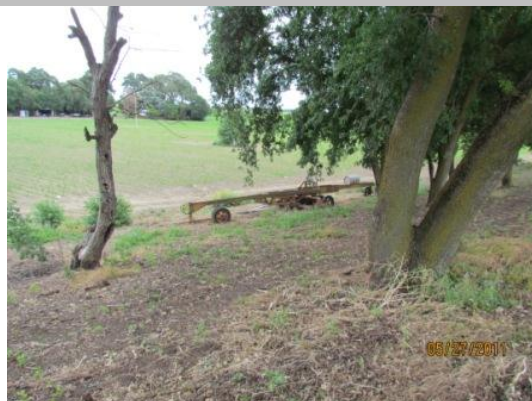
Photo 1 of 1 : FA\_2014\_RD0150\_17\_9\_20141021\_00006.jpg

Equipment on the landside toe of the levee. The picture was taken from crown looking downstream.

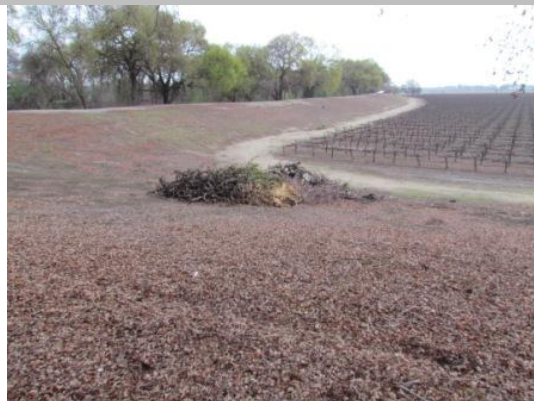
Photo 1 of 4 : FA\_2014\_RD0150\_17\_12\_20141021\_00008.jpg

Prunings were found on the landside of the levee looking upstream.

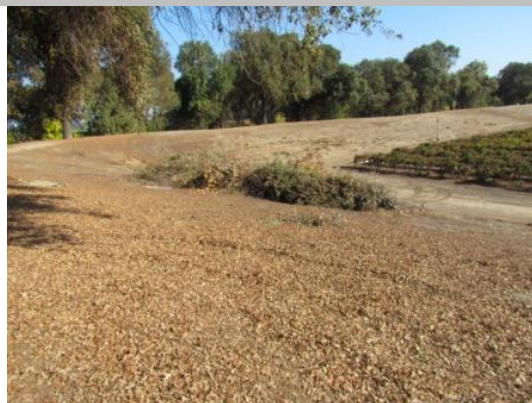
Photo 4 of 4 : FA\_2014\_RD0150\_17\_12\_20141021\_00011.jpg

Pruning was found on the landside toe of the levee looking upstream. This picture was taken during fall 2012 inspection.

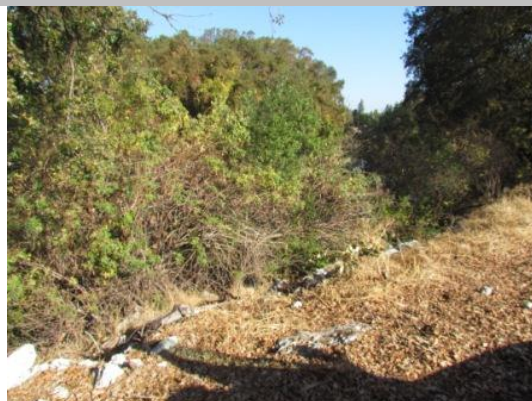
Photo 1 of 1 : FA\_2014\_RD0150\_17\_28\_20141021\_00020.jpg

Wild growth was found on the waterside slope of the levee looking upstream.

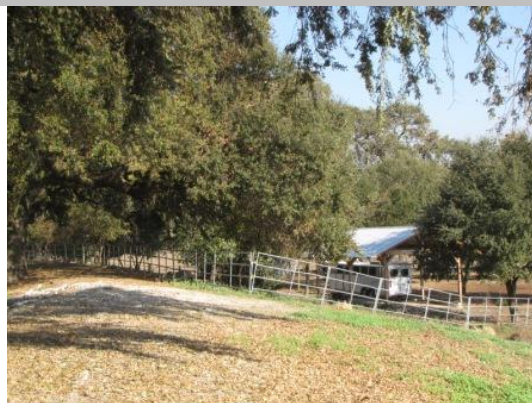
Photo 1 of 1 : FA\_2014\_RD0150\_17\_56\_20141021\_00050.jpg

View of fence around a horse pen along the shoulder of the levee and the landward slope.

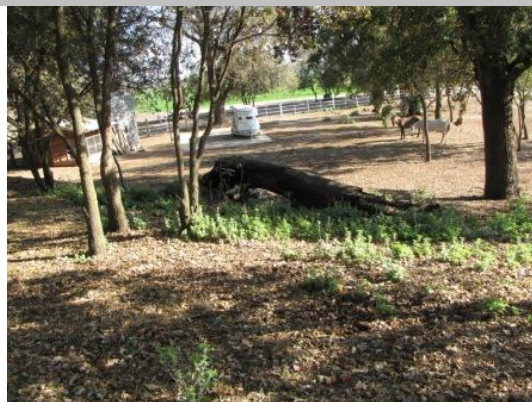
Photo 1 of 1 : FA\_2014\_RD0150\_17\_57\_20141021\_00051.jpg

View of a tree trunk lying on the landward slope blocking visibility.

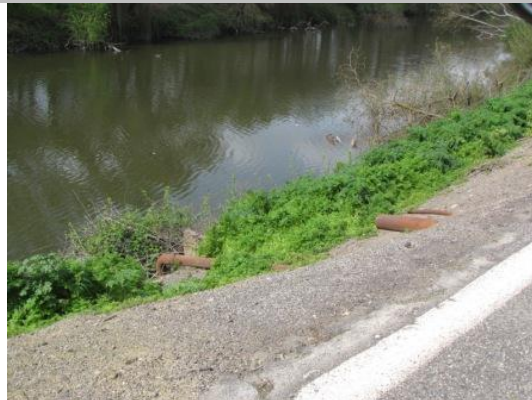
Photo 1 of 1 : FA\_2014\_RD0150\_17\_46\_20141021\_00035.jpg

View of an improperly abandoned pipe through the levee looking upstream.

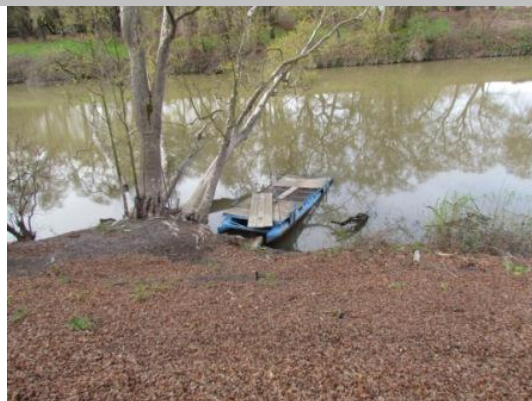
Photo 1 of 1 : FA\_2014\_RD0150\_17\_44\_20141021\_00034.jpg

An abandoned dock was found on the waterside of the levee looking upstream.

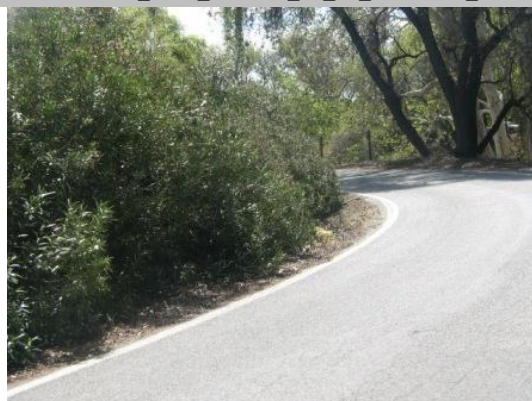
Photo 1 of 1 : FA\_2014\_RD0150\_17\_24\_20141021\_00017.jpg

Oleander on landward slope blocking view of levee from LM 6.24 to 6.32

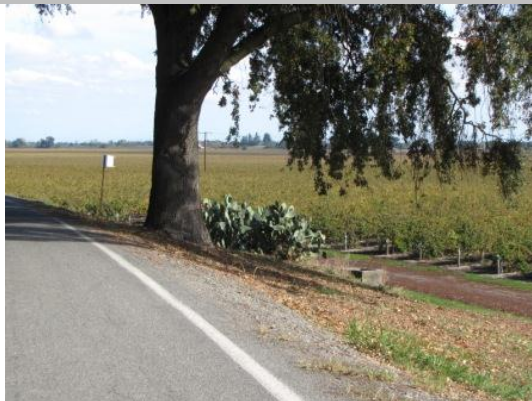
Photo 1 of 1 : FA\_2014\_RD0150\_17\_60\_20141021\_00054.jpg

View of landscaping along the landward slope.

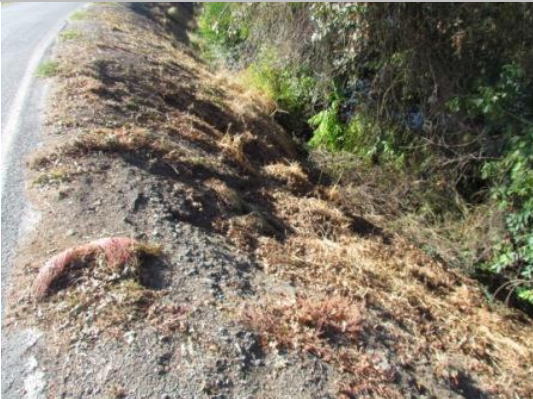
Photo 1 of 1 : FA\_2014\_RD0150\_17\_43\_20141021\_00033.jpg

Slope instability was found on the waterside of the levee looking downstream.

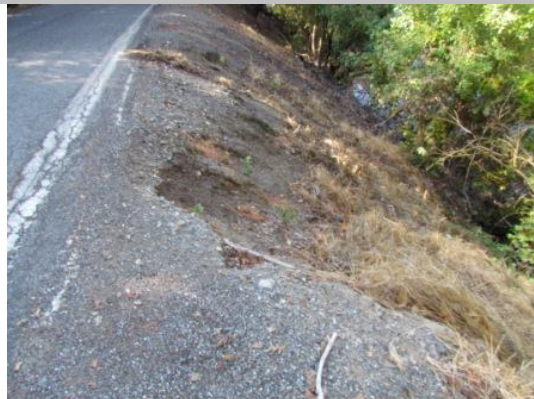
Photo 1 of 4 : FA\_2014\_RD0150\_17\_61\_20141021\_00056.jpg

Erosion was found on the waterside slope of the levee looking downstream. This updated picture was taken during fall 2012 inspection.

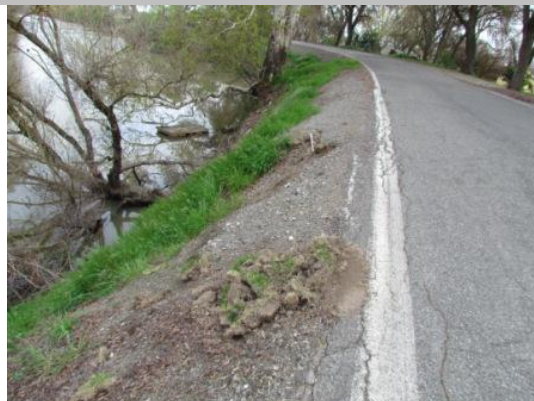
Photo 2 of 4 : FA\_2014\_RD0150\_17\_61\_20141021\_00057.jpg

Erosion on the waterside of the levee looking upstream. This picture was taken during spring 2012 inspection.

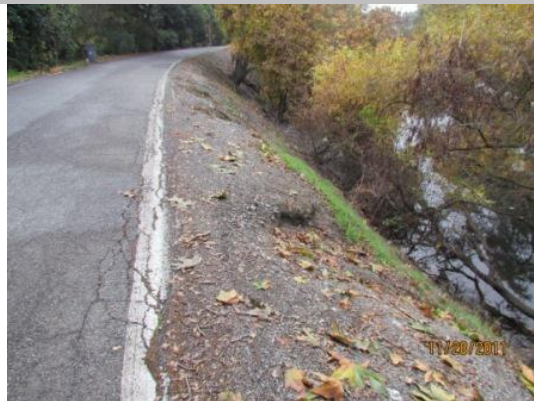
Photo 3 of 4 : FA\_2014\_RD0150\_17\_61\_20141021\_00058.jpg

Erosion was found on the waterside of the levee looking downstream. This picture was taken during fall 2011 inspection.

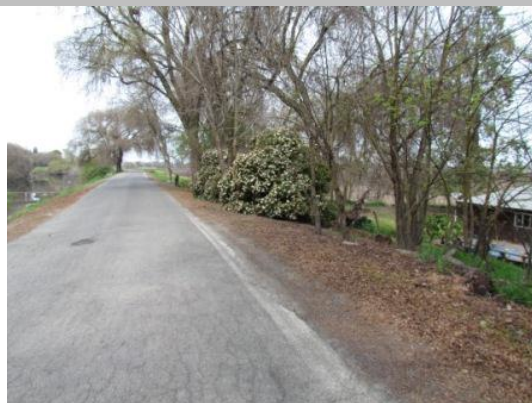
Photo 1 of 1 : FA\_2014\_RD0150\_17\_31\_20141021\_00022.jpg

Landscaping was found on the landside shoulder of the levee looking upstream.

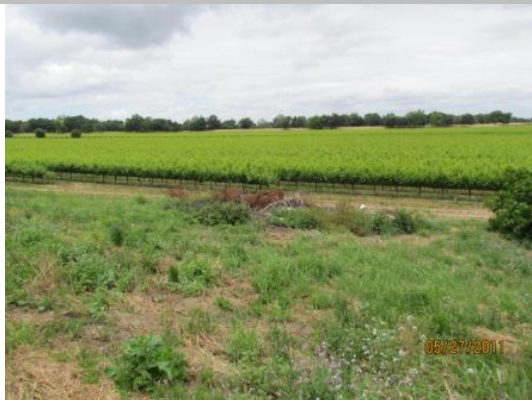
Photo 1 of 3 : FA\_2014\_RD0150\_17\_935\_20141021\_00101.jpg

Prunings located on the toe of landward side of the levee. The picture was taken from the crown looking upstream.

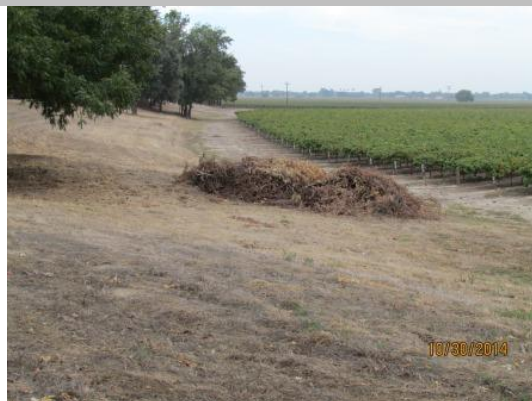
Photo 1 of 1 : FA\_2014\_RD0150\_17\_82\_20141104\_00127.jpg

Prunings were found on the landside toe of the levee looking upstream.

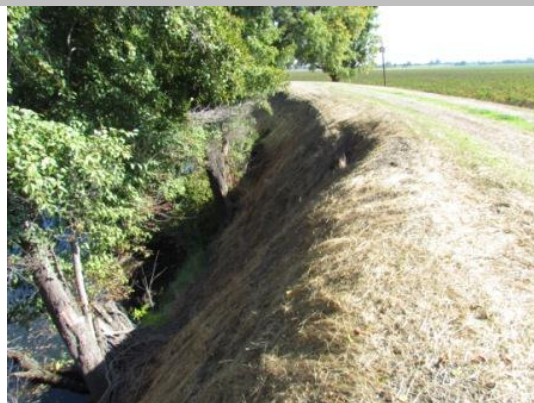
Slope instability was found on the waterside shoulder of the levee looking upstream. This picture was taken during fall 2012 inspection.

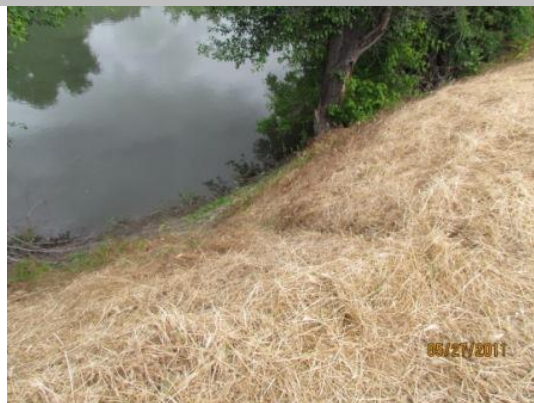
Slope instability on the waterside slope of the levee. The picture was taken from the crown looking upstream.

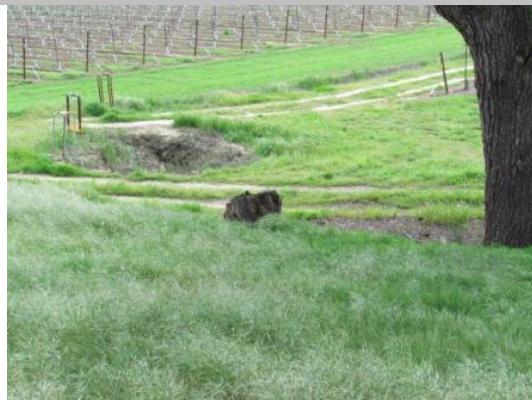
Photo 1 of 1 : FA\_2014\_RD0150\_17\_90\_20141021\_00088.jpg

A tree stump was found on the landside of the levee looking upstream.

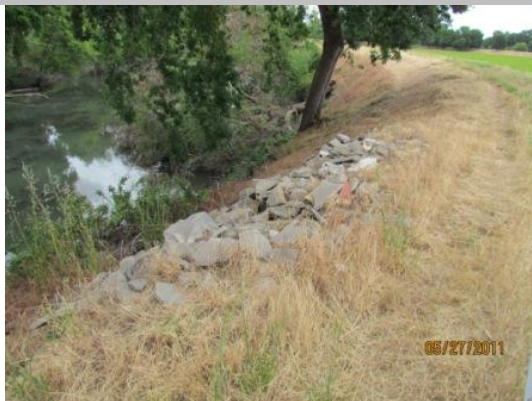
Broken concrete pipe was left on the waterside slope of the levee. The picture was taken from the crown looking upstream.

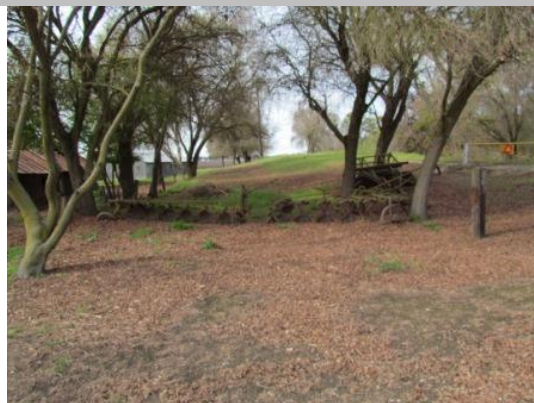
Equipment was found on the landside of the levee looking downstream.
